SCREENING SITE INSPECTION REPORT
FOR
U.S. STEEL CORPORATION, JOLIET WORKS
JOLIET, ILLINOIS
U.S. EPA ID: ILD005454566
SS ID: NONE
TDD: F05-8905-029
PAN: FILO333SA

OCTOBER 2, 1990

SIGNATURE PAGE
FOR
SCREENING SITE INSPECTION REPORT
FOR
U.S. STEEL CORPORATION, JOLIET WORKS
JOLIET, ILLINOIS
U.S. EPA ID: ILD005454566
SS ID: NONE
TDD: F05-8905-029
PAN: FIL0333SA

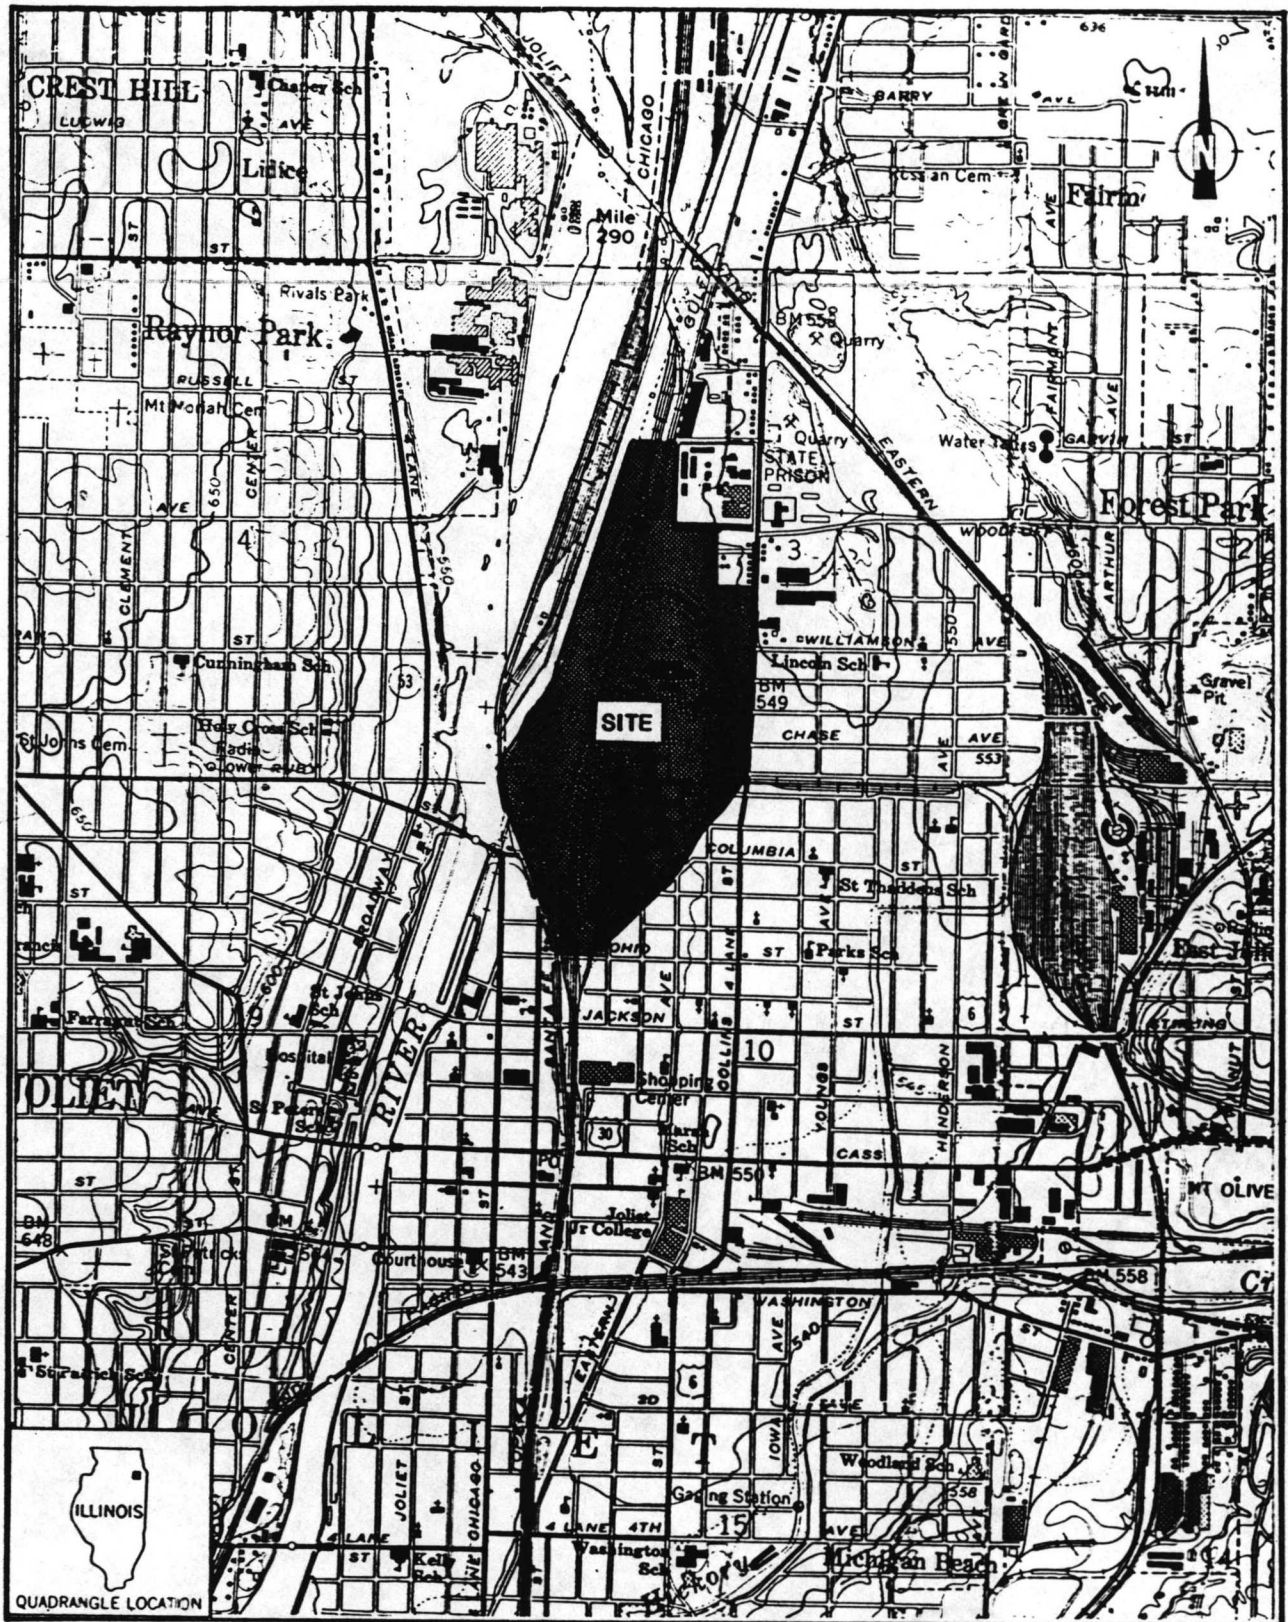
FIGURE 2-2 SITE PROPERTY DIVISIONS

The USSJW site is currently divided into 11 lots of various sizes (see Figure 2-2 for site property divisions). USX Corporation (USX) owns four lots and a portion of a fifth. These lots include lot 2 (approximately 6 acres), lot 8 (approximately 5 acres), lot 6 (approximately 49 acres), lot 11 (approximately 26 acres), and a portion of lot 4 (approximately 1/2 acre of the total 3 acres). American Steel & Wire Corporation (AS&W) of Cuyahoga Heights, Ohio, owns three lots, including lot 5 (approximately 10 acres), lot 7 (approximately 42 acres), and lot 9 (approximately 2 acres). Lot 7 and the majority of

Active railroad lines owned by Chicago and Alton Railroad run north and south through the site, dividing the site into east and west portions. The east portion contains lot 1 and lots 7 through 11; the west portion contains lots 2 through 6 (see Figure 2-2).

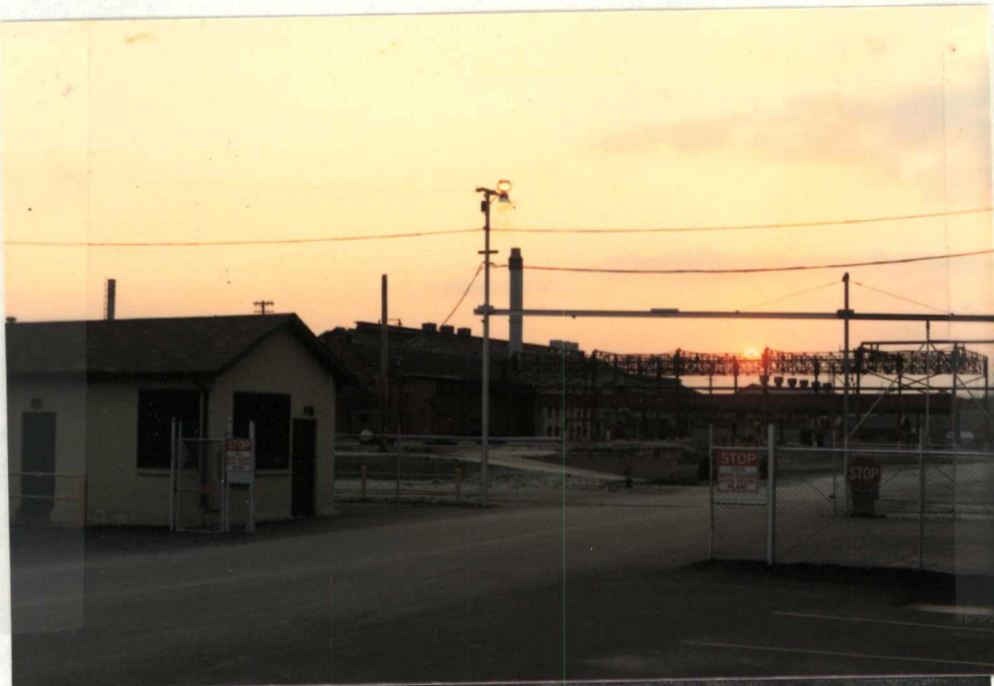
DESCRIPTION: Entrance gate and guard house.DATE: 10/25/89TIME: 1620DIRECTION OF
PHOTOGRAPH:NEWEATHER
CONDITIONS:Sunny,70's

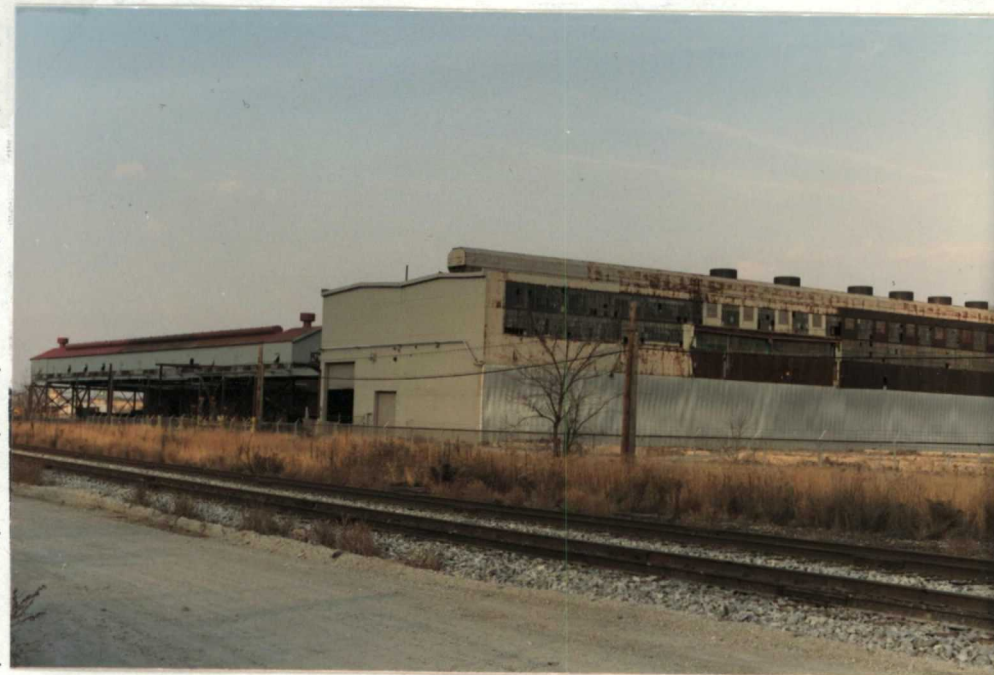
DESCRIPTION: Southeast corner of AS&W property
line. The billet process/grinding building is shown.

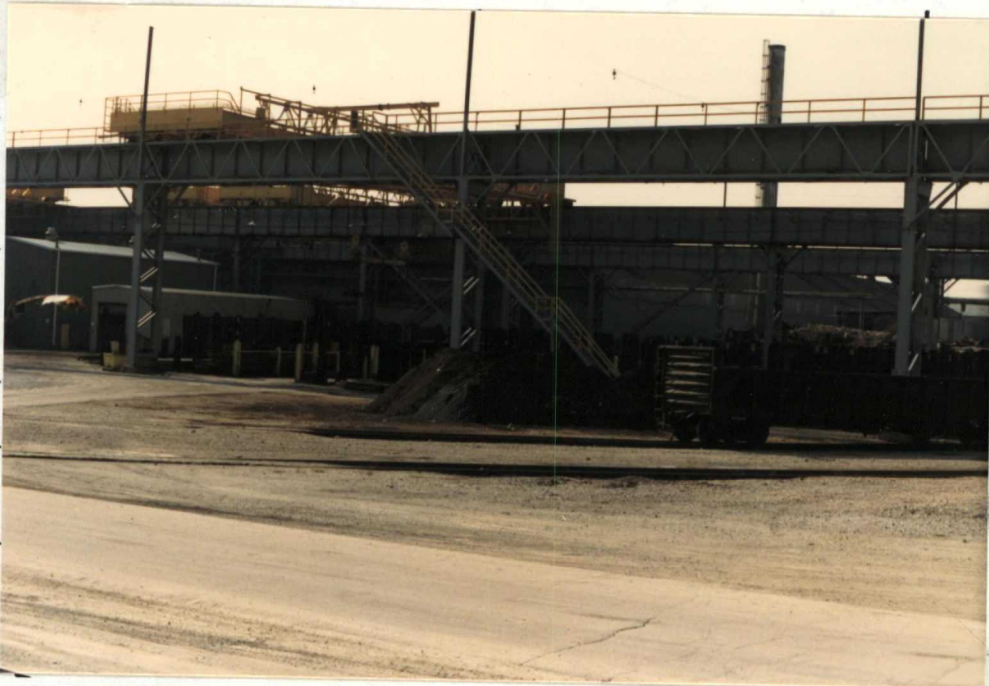
DESCRIPTION: Billet storage area. A pile of swarf
is located near the rail car.

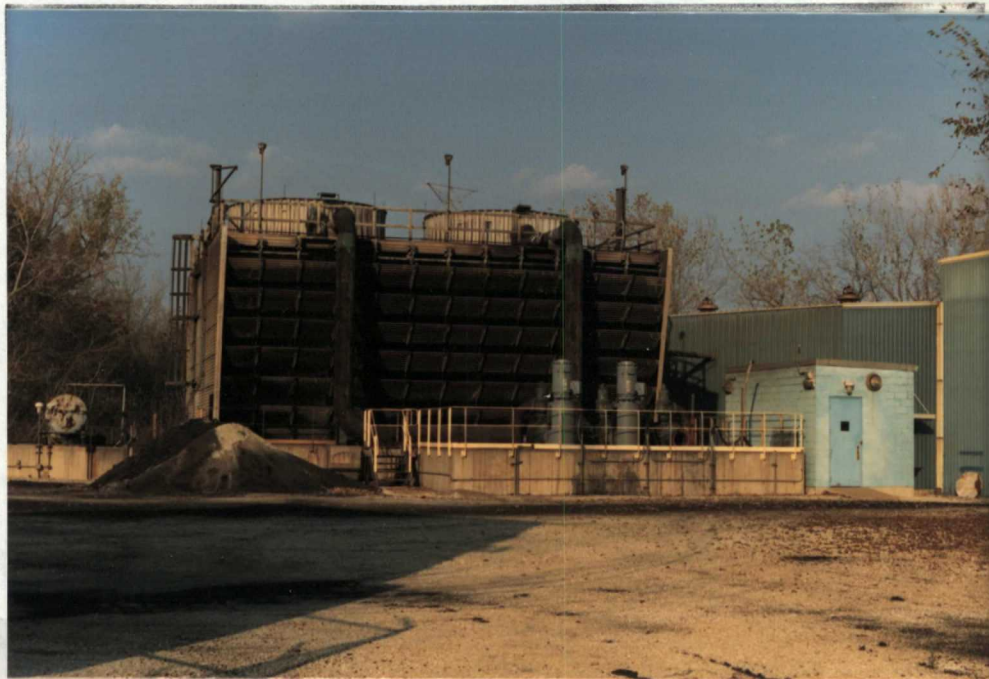
DESCRIPTION: The cooling tower portion of the
WWTP facility.

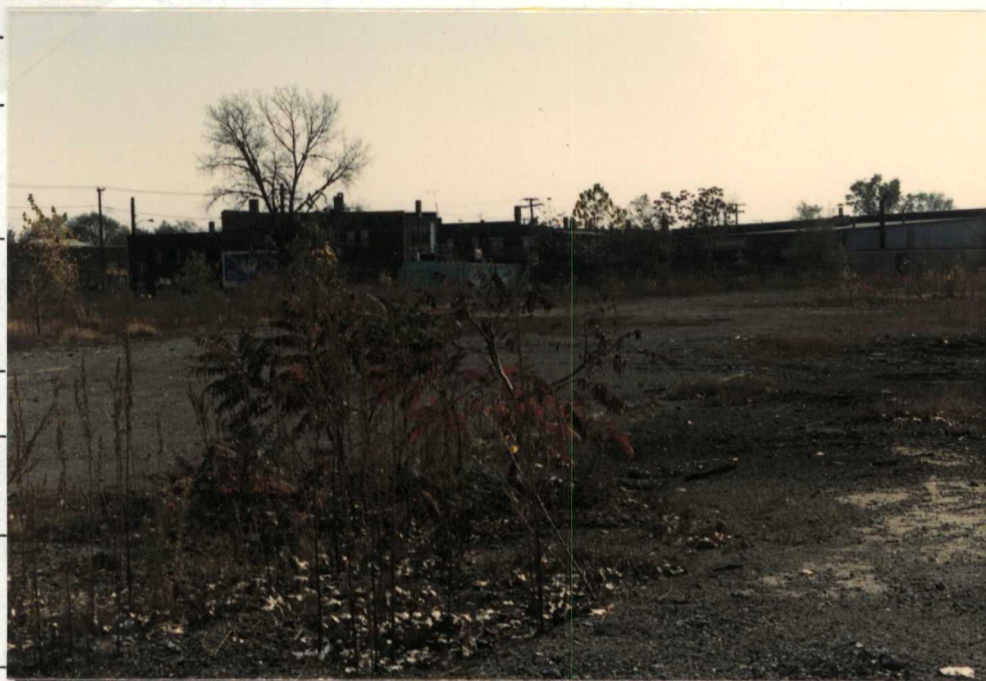
DESCRIPTION: Lot #8. The splice bar mill was located
here.DATE: 10/25/89TIME: 1300DIRECTION OF
PHOTOGRAPH:NWWEATHER
CONDITIONS:Sunny,70's

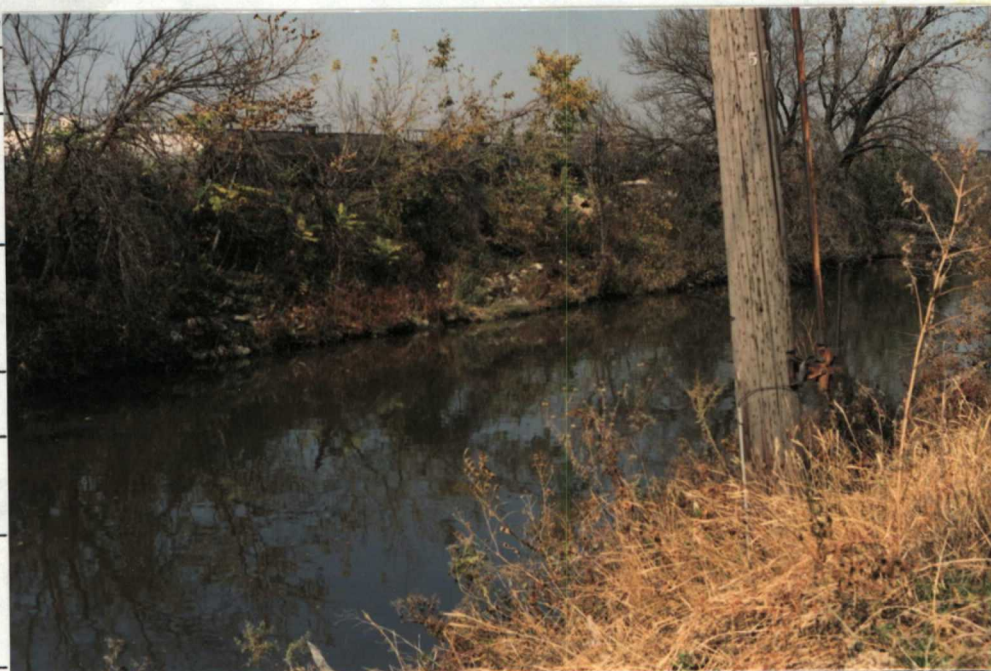
DESCRIPTION: The I&M Canal along the west
border of the site. Photograph was taken from
the former landfill.

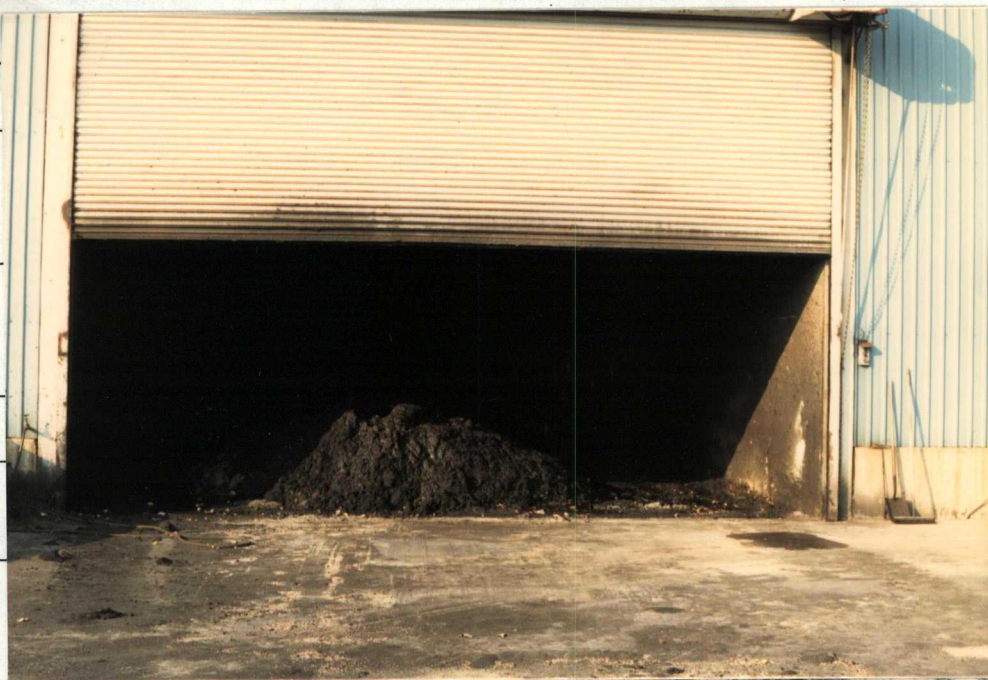
DESCRIPTION: WWTP sludge at the treatment
building.DATE: 10/25/89TIME: 1610DIRECTION OF
PHOTOGRAPH:EWEATHER
CONDITIONS:Sunny,70's

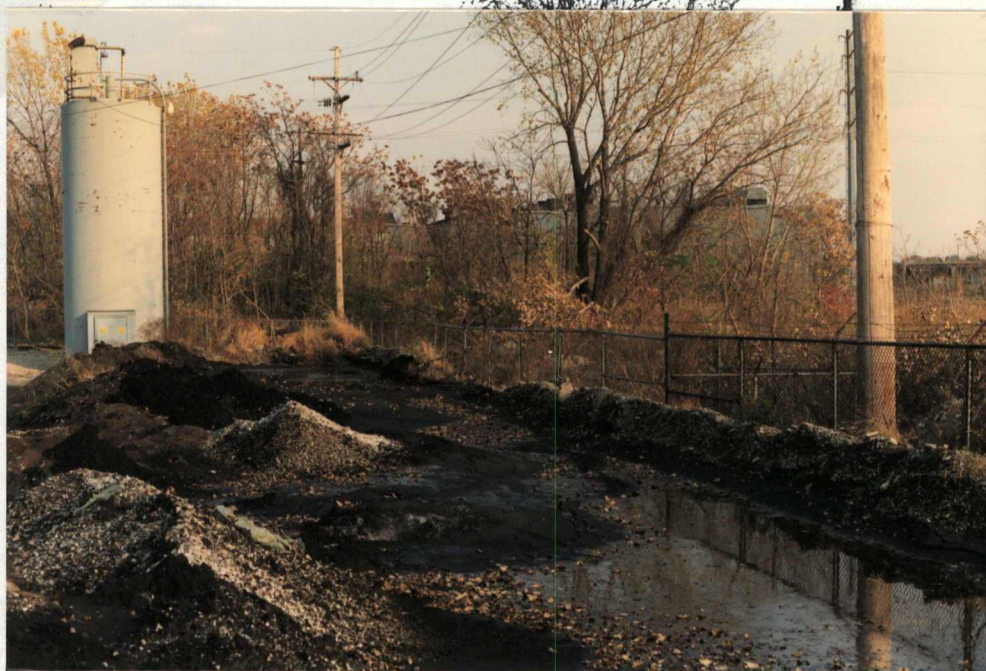
DESCRIPTION: Sludge pit near the WWTP facility.

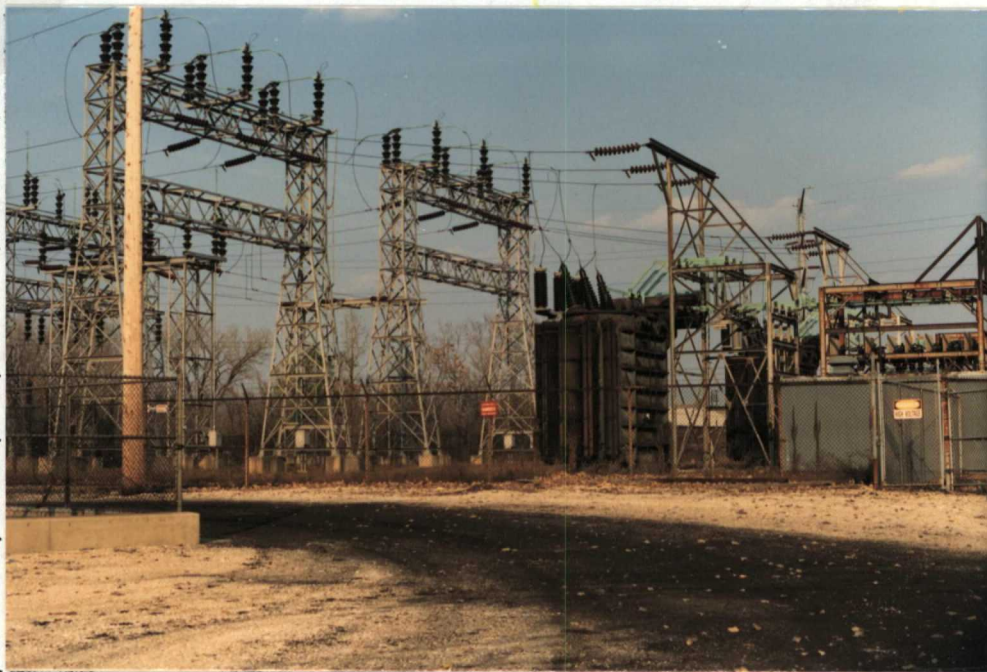
An electrical substation is located east of the WWTP facilities. The substation is completely surrounded by a fence with a locked gate, separate from the WWTP facilities. The fences surrounding the WWTP facilities and the substation were the only fences observed on the western portion of the site.

DESCRIPTION: The substation located on lot #5.

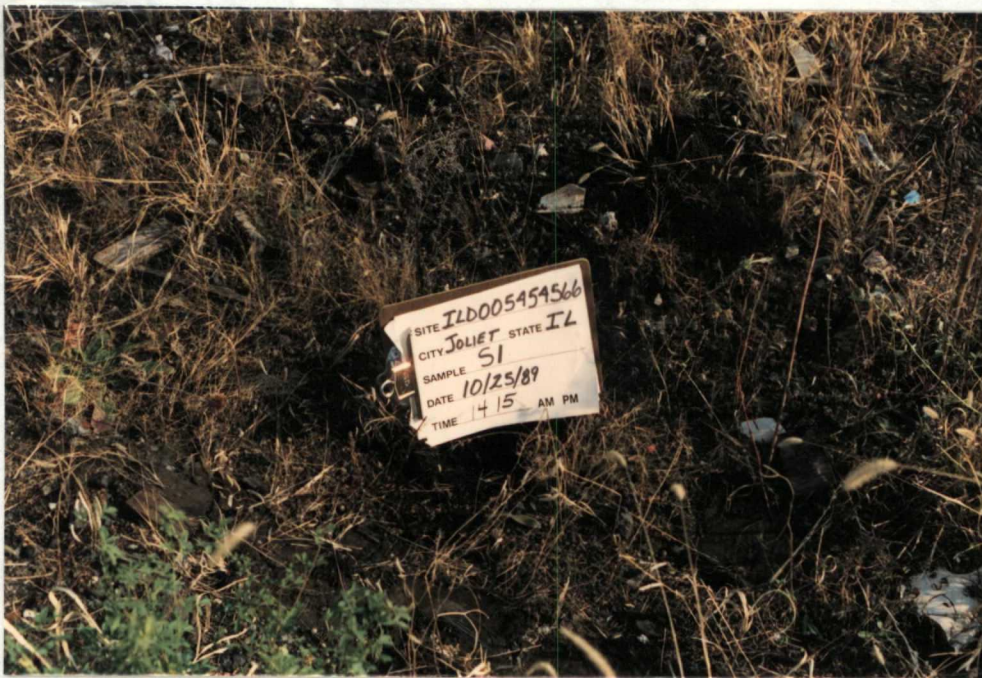
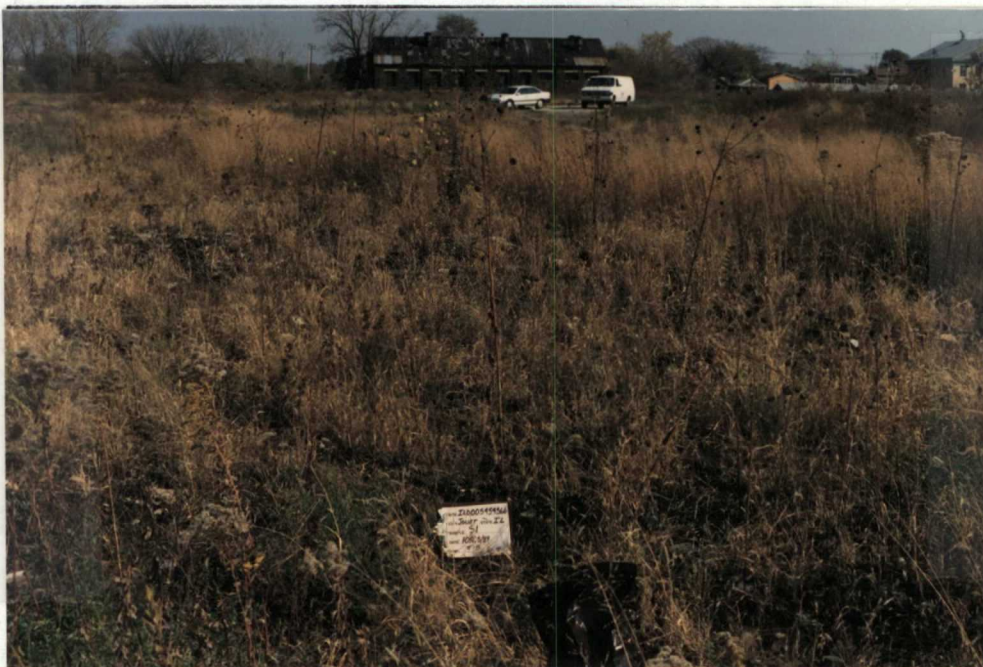
DESCRIPTION: close up view of soil sample S1.locationDATE: 10/25/89TIME: 1415DIRECTION OF
PHOTOGRAPH:EWEATHER
CONDITIONS:Sunny,70's

DESCRIPTION: Perspective view of soil sample S1 location.

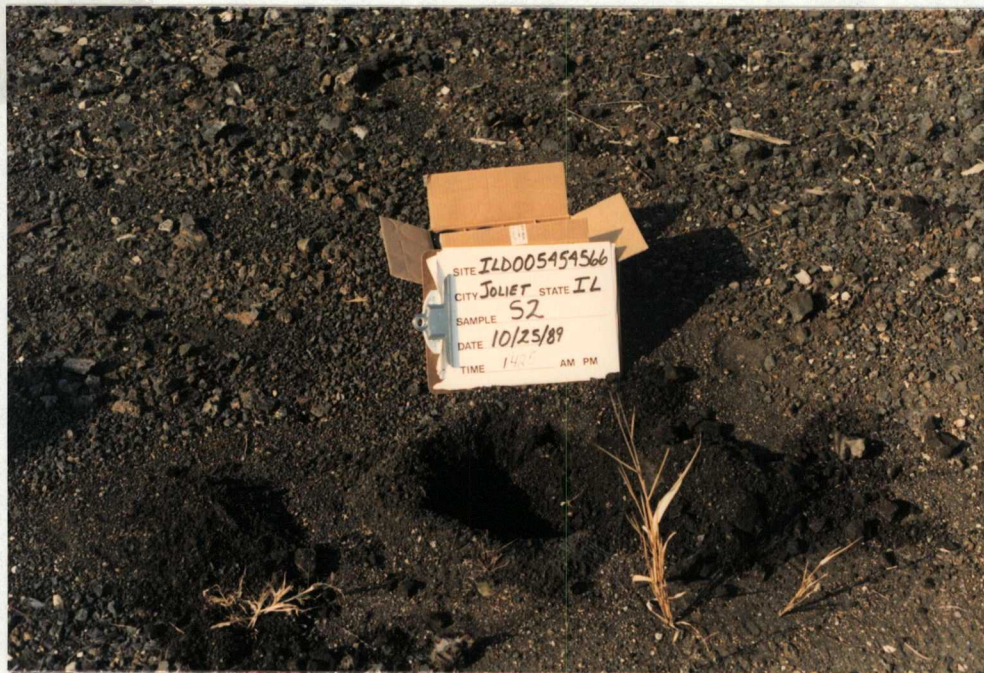
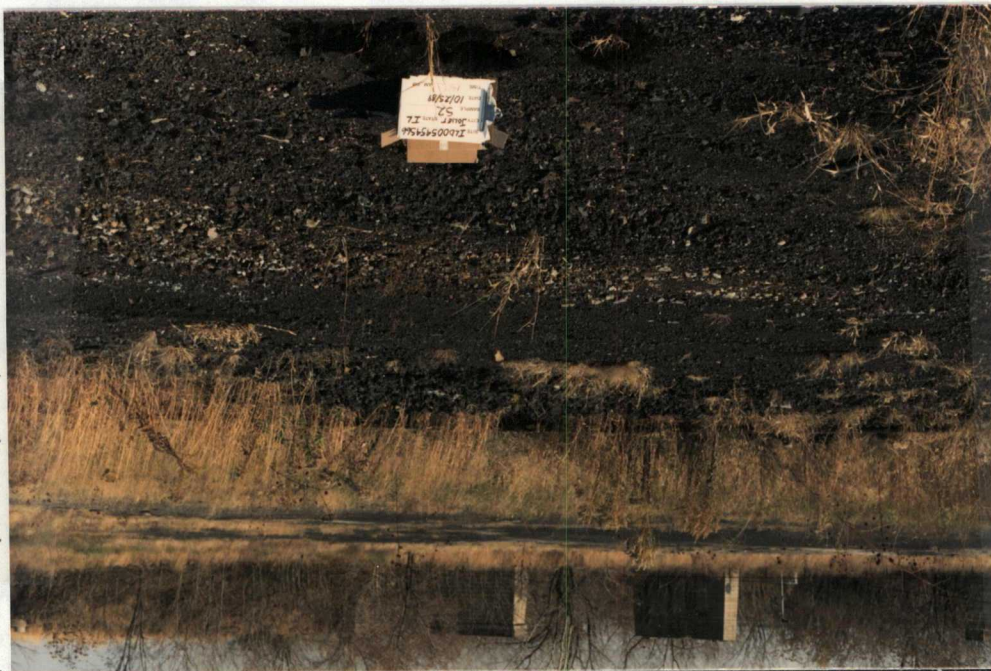
DESCRIPTION: Close up view of soil sample S2 locationDATE: 10/25/89TIME: 1425DIRECTION OF
PHOTOGRAPH:NWEATHER
CONDITIONS:Sunny,70's

DESCRIPTION: Perspective view of soil sample S2 location.

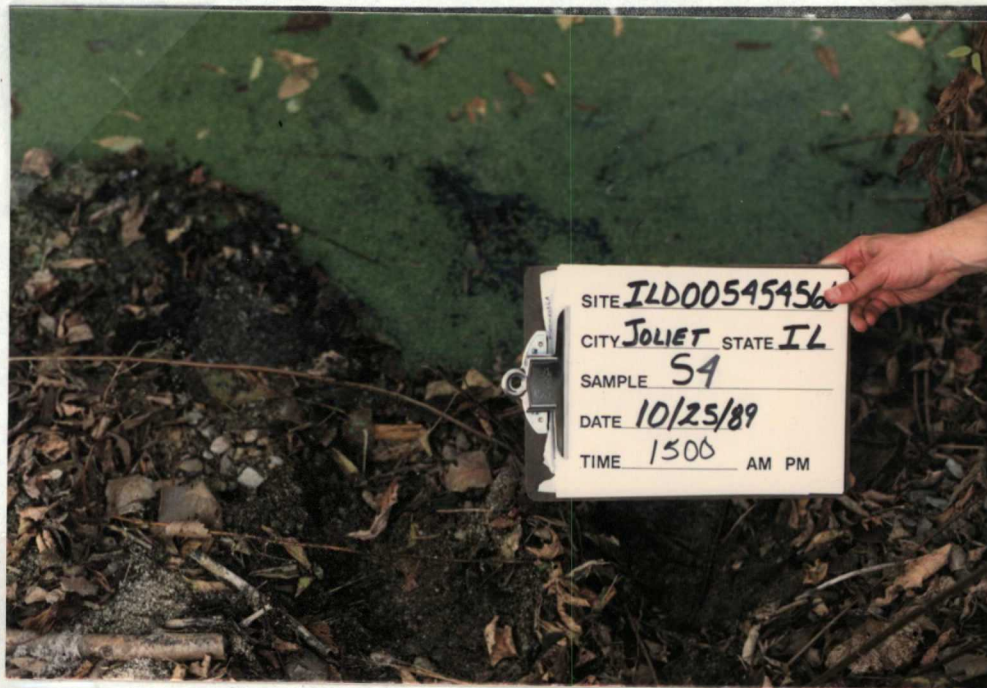
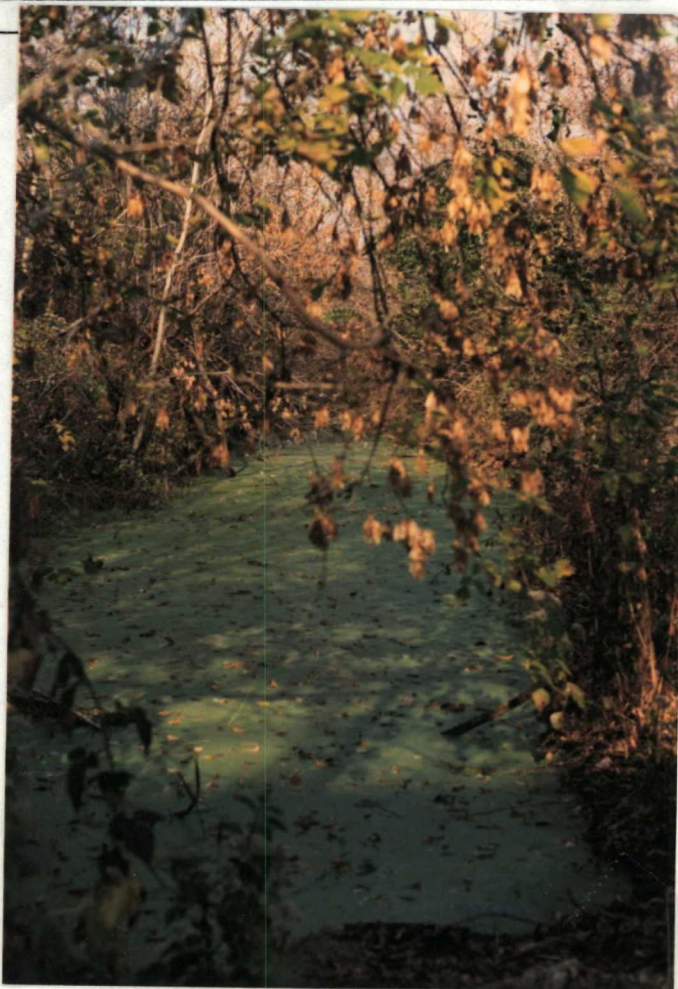
DESCRIPTION: Close up view of sediment sample S4
location.DATE: 10/25/89TIME: 1500DIRECTION OF
PHOTOGRAPH:N

CONDITIONS: Sunny, 70'sPHOTOGRAPHED BY: J. DicksonSAMPLE ID
(if applicable): S4DESCRIPTION: Perspective
view of sediment
sample S4 location.

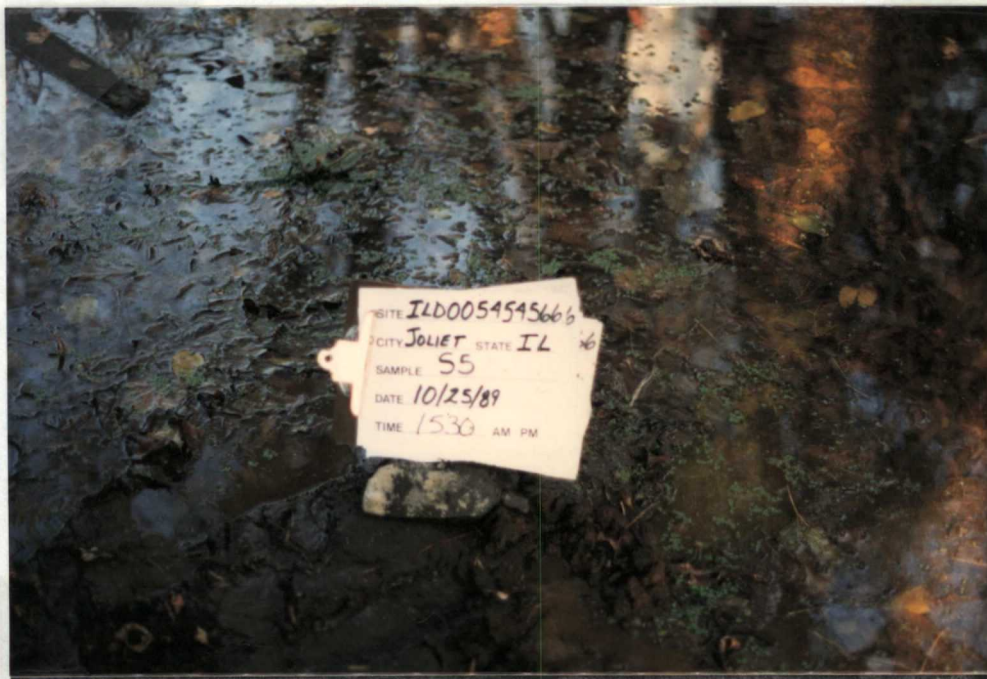
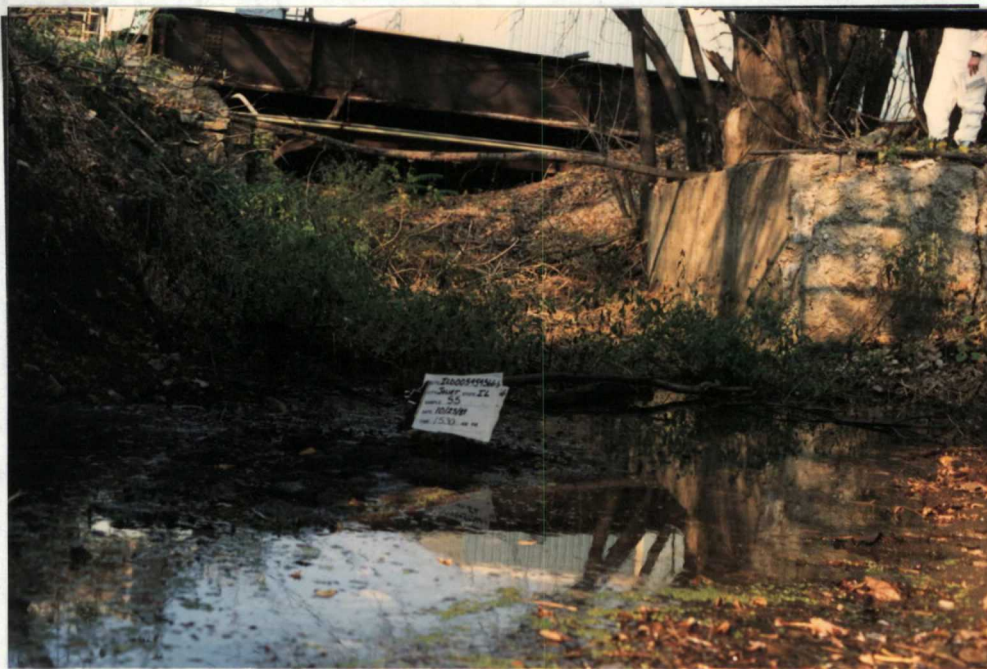
- TCL compounds were detected in sediment samples collected from an on-site ditch that leads to the Des Plaines River (S5), and from near the WTP outfall (S6), at concentrations above the background concentration.
- TAL analytes were detected in elevated concentrations in all on-site soil/sediment samples.
- An approximately 10% slope is found along the west boundary of the site, which adjoins I & M Canal and the Des Plaines River.

DESCRIPTION: Close up view of sediment sample S5
location.DATE: 10/25/89TIME: 1530DIRECTION OF
PHOTOGRAPH:NEWEATHER
CONDITIONS:Sunny,70's

DESCRIPTION: Perspective view of sediment sample
S5 location.

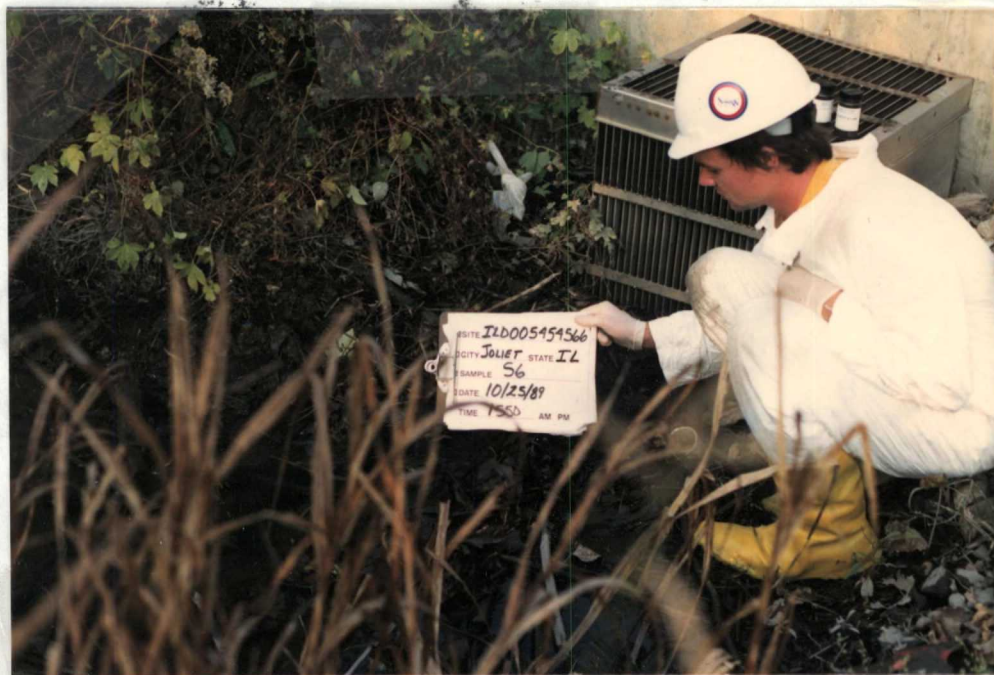
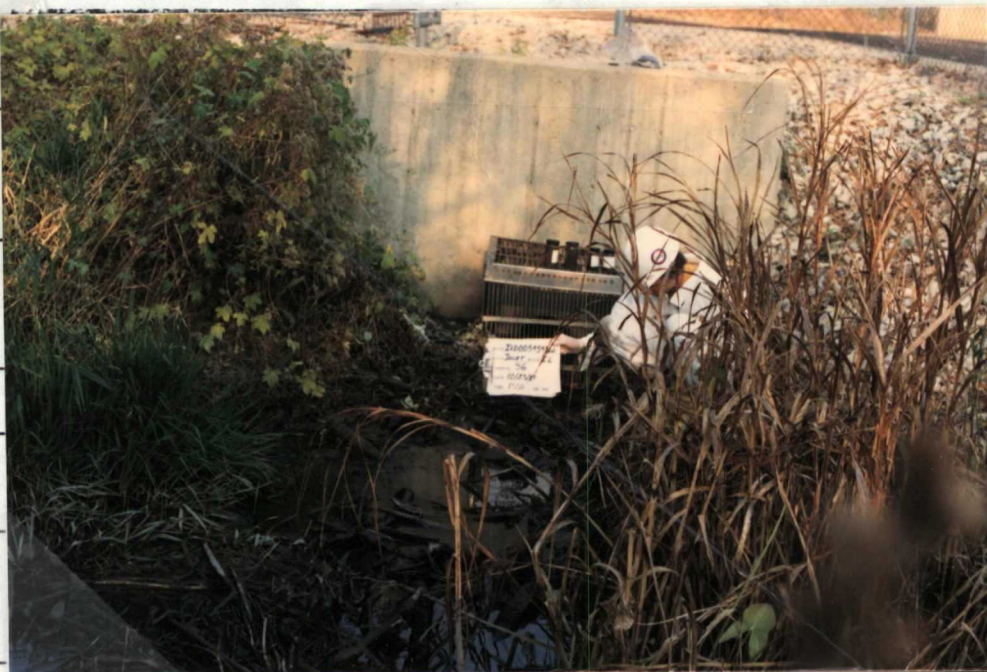
DESCRIPTION: Close up view of sediment sampleS6 location.DATE: 10/25/89TIME: 1550DIRECTION OF
PHOTOGRAPH:NEWEATHER
CONDITIONS:Sunny,70's

DESCRIPTION: Perspective view of sediment sampleS6 location.

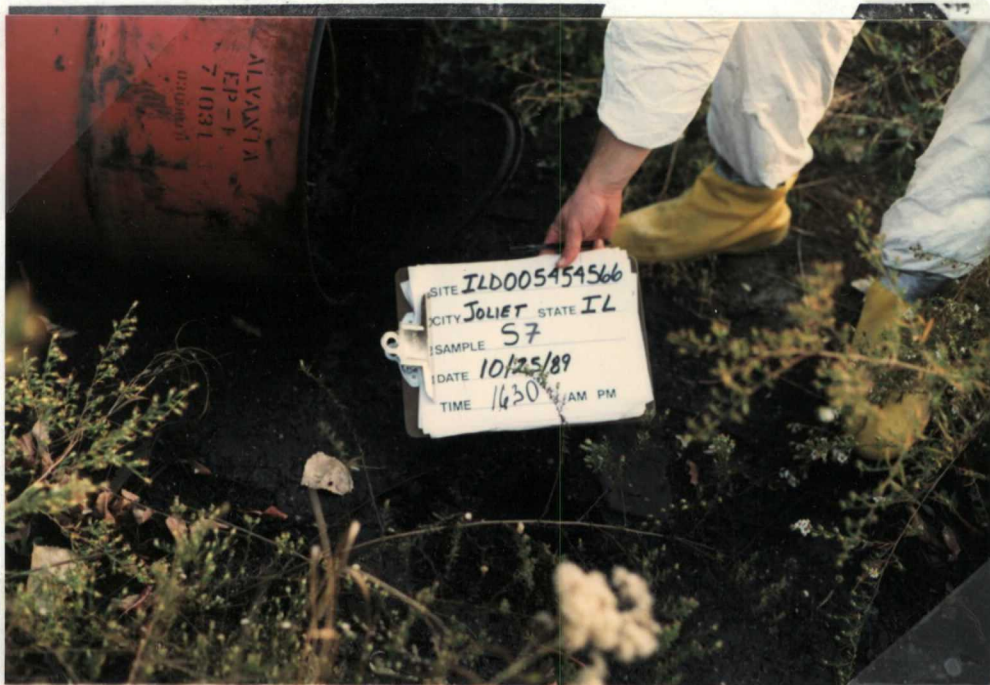
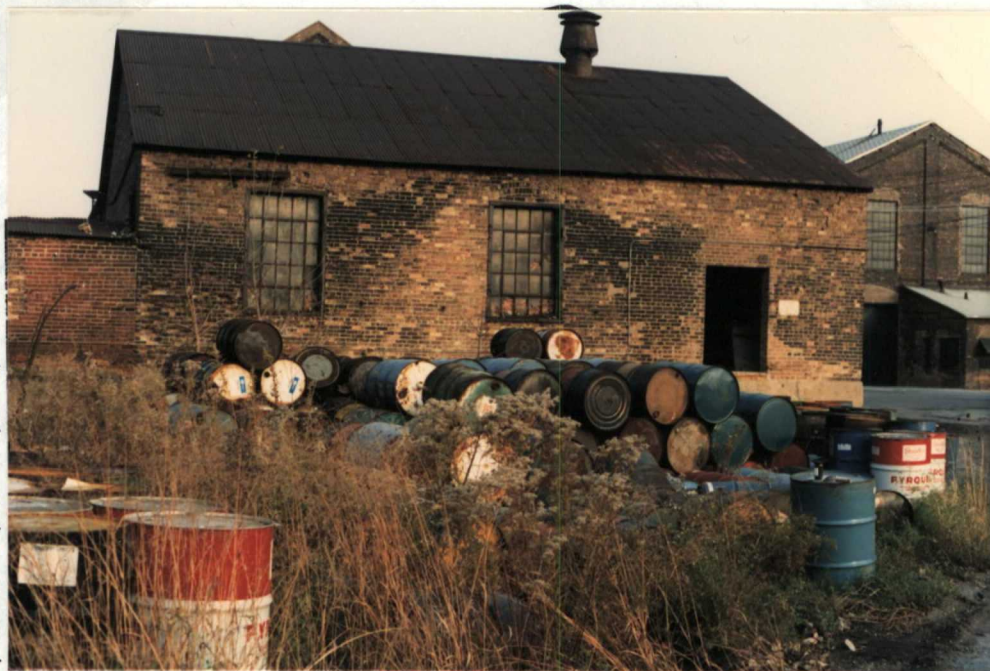
Soil sample S7 was a surface soil sample collected from an area of stained soil near the drum storage area. This sampling location was selected to determine whether TCL compounds or TAL analytes had entered the ground in this area.

close up view of soil sample S7 location.DATE: 10/25/89TIME: 1630DIRECTION OF
PHOTOGRAPH:EWEATHER
CONDITIONS:Sunny,70's

Perspective view of soil sample S7 location.

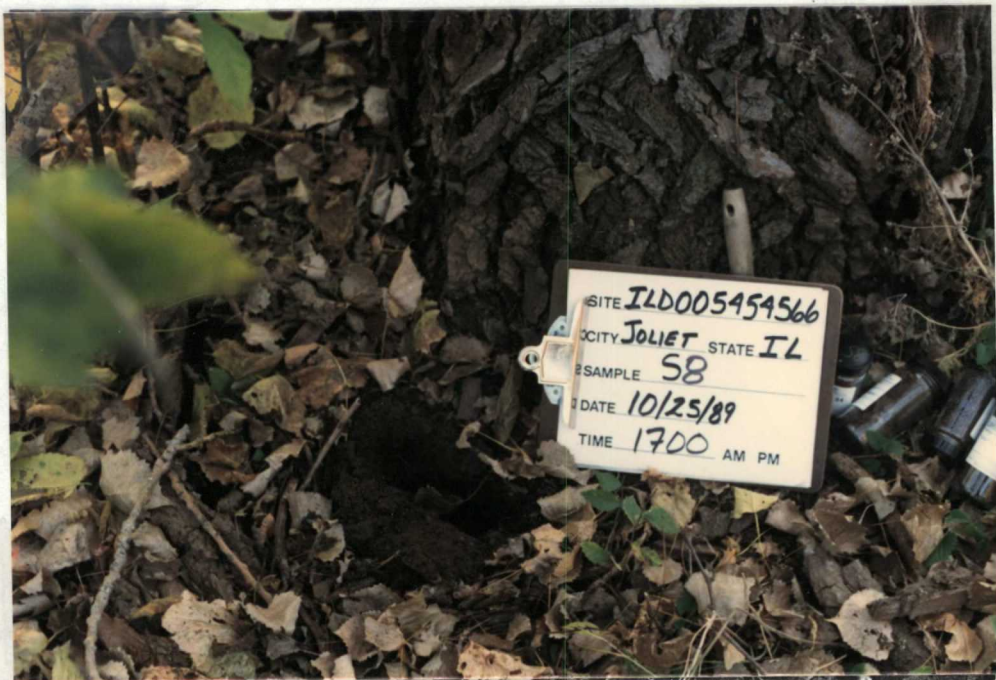
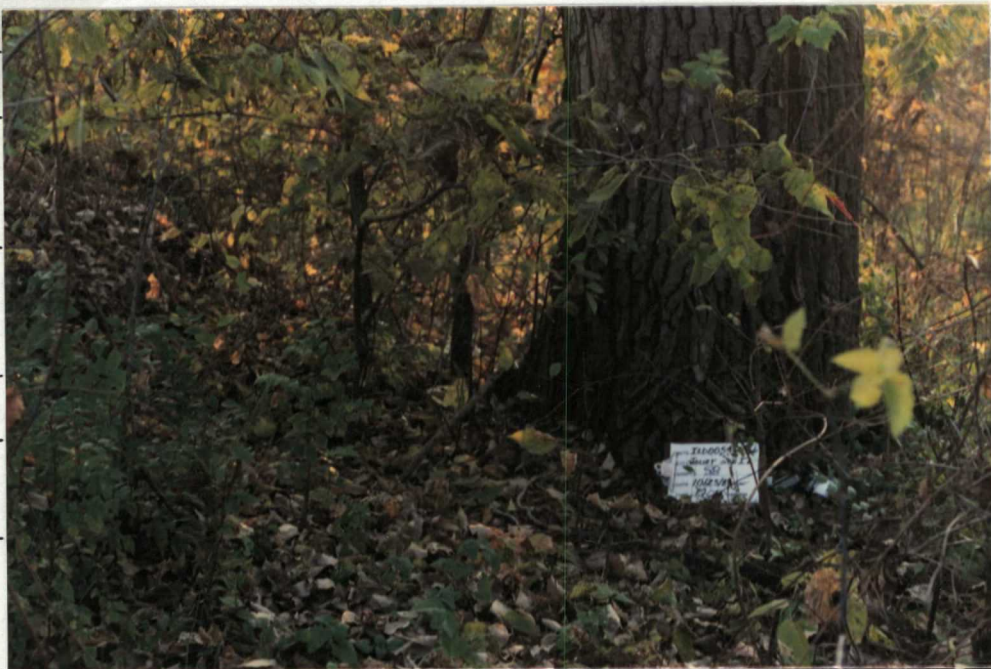
Soil sample S8, a potential background sample, was a grab surface soil sample collected in a wooded area along the eastern border of the east portion of the site. The sampling location was chosen because it appeared to be a relatively undisturbed area and no hazardous wastes were known to have been stored or disposed of in the vicinity. Sample S8 was collected to determine the representative chemical content of the soil in the area of the site.

DESCRIPTION: Close up view of soil sample S8 location.DATE: 10/25/89TIME: 1700DIRECTION OF
PHOTOGRAPH:WWEATHER
CONDITIONS:Sunny,70's

DESCRIPTION: Perspective view of soil sample S8 location.
